Published in:
Safety Science

**Violent explosion after
inadvertent mixing of nitric
acid and isopropanol –
review 15 years later finds
basic accident data
corrupted, no evidence of
broad learning**

Abstract

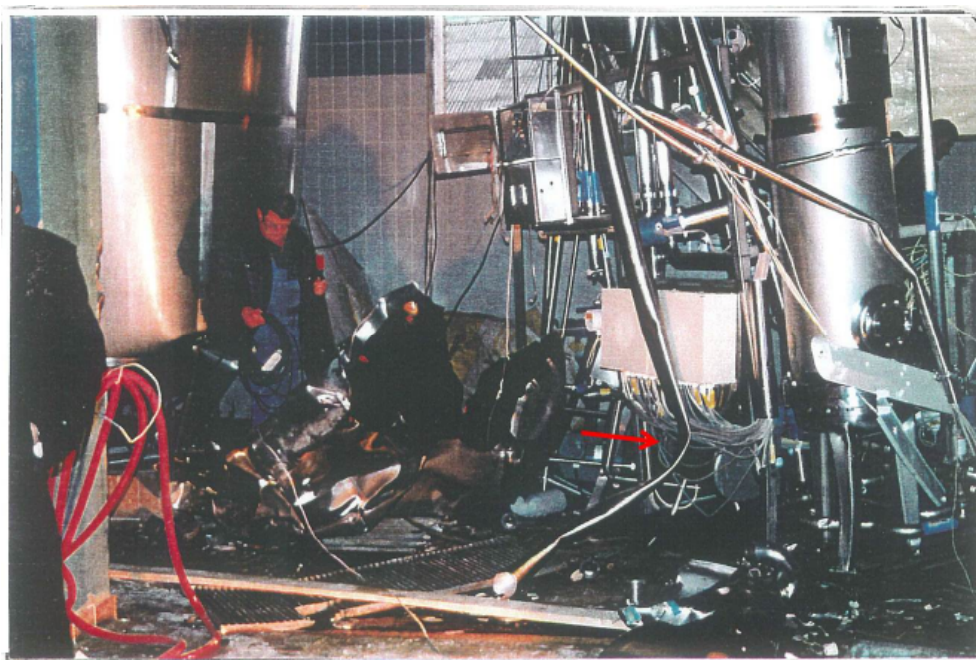
Figure 2 Right: damaged filter unit, left: caustic tank. Note flattened steel piping (arrow). Photo courtesy of company.

The force of the explosion flattened stainless steel piping. The upper part of the caustic tank was deformed and the tank leg facing the P3 tank was bent 45 degrees upwards. The adjacent filter unit was destroyed (Figure 2).

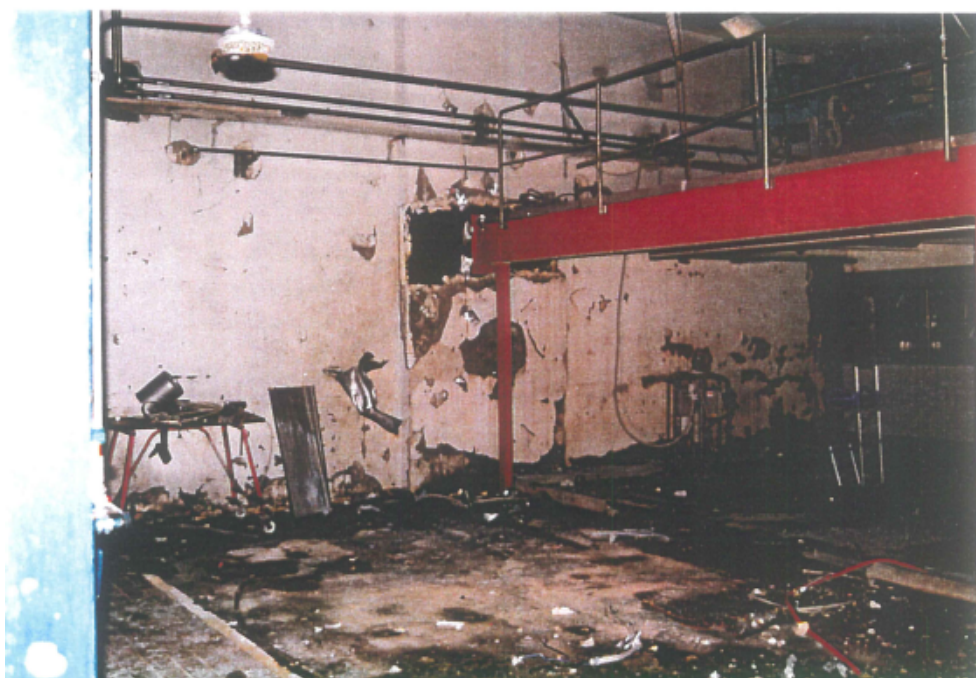
Figure 3 Tank fragments lodged in heavy concrete wall (marked as location b in Figure 1). Photo courtesy of company.

The severity of the explosion is perhaps best revealed by fragmentation damage. The P3 tank disintegrated and tore the adjacent nitric acid tank apart. Tank steel fragments lodged into the solid concrete wall (Figure 3). A stainless steel flange with an estimated weight of 8-10 kg originating from the bottom of the P3 tank traversed the hall, penetrated an electrical cabinet and caused a black-out (Figure 4). The nearby water tank was pockmarked by fragment impact, mostly at the lower part of the tank. Scattered crumbled tank fragments, damaged machinery and a deformed metal handrail is evidence of other forceful impacts. The concrete pillars had corners knocked off.
